Degradation of Continuous Fiber Ceramic Matrix Composites Under Constant-Load Conditions

Michael C. Halbig and David N. Brewer
U.S. Army Research Laboratory, Glenn Research Center, Cleveland, Ohio

Prepared for the
Symposium on Environmental, Mechanical, and Thermal Properties and Performance
of Continuous Fiber Ceramic Composite (CFCC) Materials and Components
sponsored by the ASTM Committee C-28 on Advanced Ceramics
Seattle, Washington, May 18, 1999

1. AGENCY USE ONLY (Leave blank)	2. REPORT DATE January 2000	3. REPORT TYPE AND DATES COVERED Technical Memorandum		
4. TITLE AND SUBTITLE Degradation of Continuous Fiber Ceramic Matrix Composites Under Constant-Load Conditions		5. FUNDING NUMBERS WU-242-82-77-00 1L161102AH45

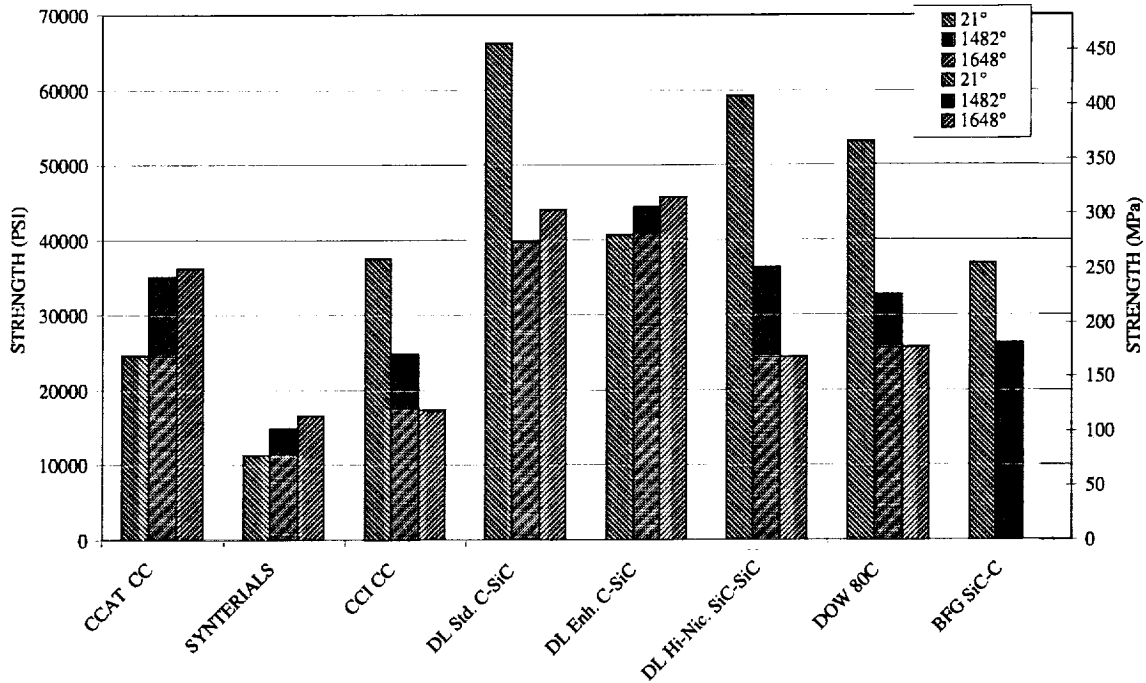
Figure 1—The tensile strength of eight of the program materials at temperatures of 21, 1482 and 1648°C (70, 2700 and 3000°F). Tensile testing conducted by SRI.

In order to interpret better the results of stressed oxidation testing, the ultimate tensile strength of the materials should be known. The results of tensile tests conducted by SRI at 21, 1482, and 1648°C (70, 2700 and 3000°F) are shown in Figure 1. As illustrated by the strengths at elevated temperatures, the C/SiC composites typically have higher strengths than the SiC/SiC composites. The specific C/C materials supplied by the vendors show some variation in strength.

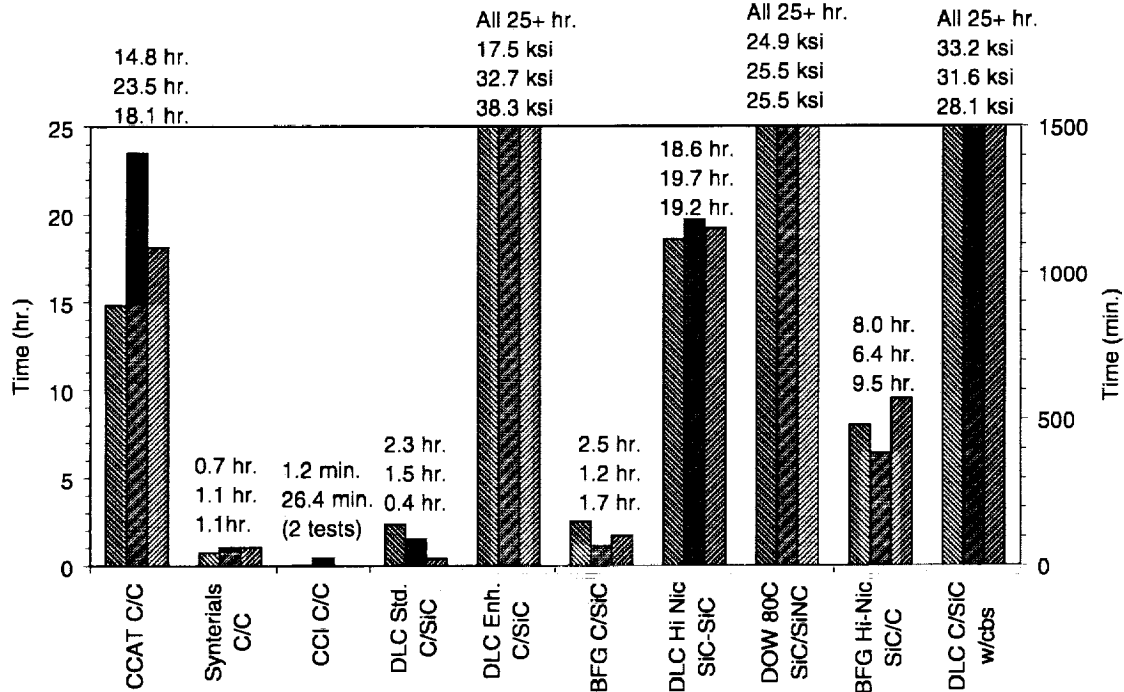
Figure 2—Times to failure for stressed oxidation tests at 1454°C/69 MPa.

The times to failure for the samples stressed oxidation tested at 69 MPa are shown in Figure 2. Three of the materials survived 25 hours of exposure. The three materials (DLC enhanced C/SiC, DLC C/SiC w/cbs, and Dow SiC/SiNC) all had oxidation protection enhancements which, seem to be a key in prolonging the life of both C/SiC and SiC/SiC composites. The DLC enhanced C/SiC material has a boron containing particulate in the composite that acts as an oxygen getter and forms borosilicate glasses that seal cracks and protect the fibers from oxidation. The DLC C/SiC material with a cbs (carbon, boron, and silicon) coating uses a similar method of oxidation protection as the enhanced C/SiC material, however, a boron containing coating also provides an exterior form of protection. The Dow SiC/SiNC uses a proprietary, non-carbon, interphase on the SiC fibers. The three materials had relatively high residual strengths as determined from room temperature tensile tests. Two other materials, CCAT C/C and DLC SiC/SiC, did fail within 25 hr, but had relatively longer lives compared to the five other materials that failed at shorter times.

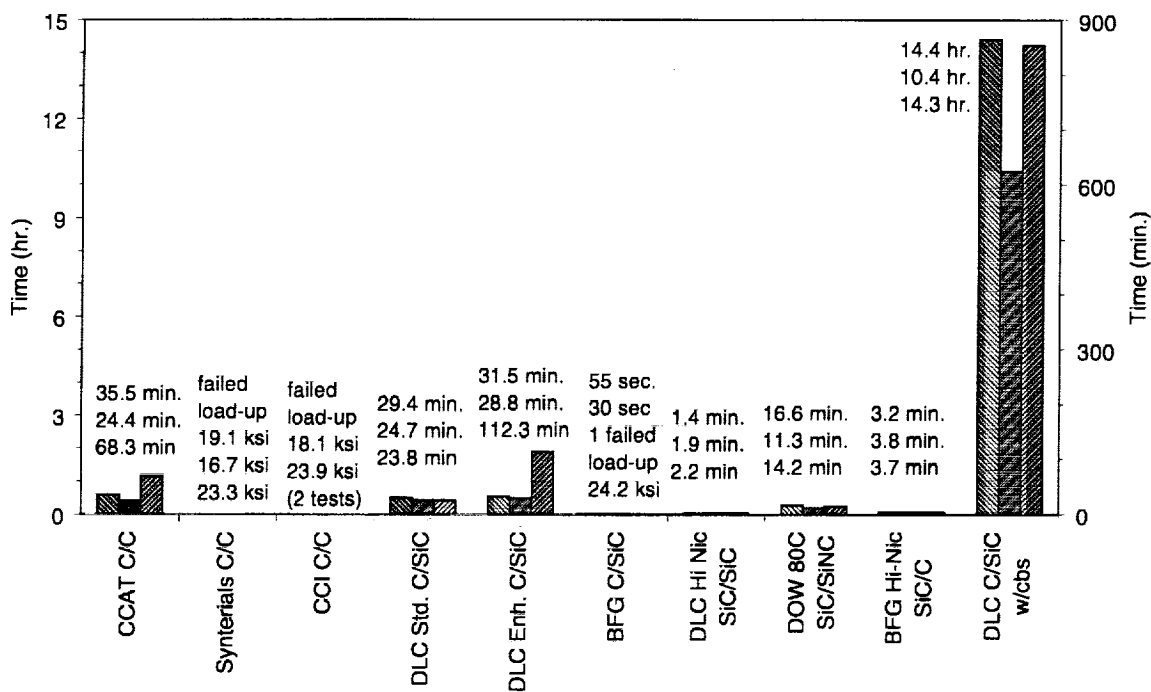
Figure 3—Times to failure for stressed oxidation tests at 1454°C/172 MPa.

The times to failure for testing at a stress of 172 MPa are shown in Figure 3. All of the materials either failed on load-up or had much shorter lives than at 69 MPa with the exception of the DLC C/SiC material with the cbs coating. This material had lives over ten hours while the other materials either failed load-up or had lives of a few minutes or about half an hour. The cbs coating enhancement in the DLC material seems to be effective in sealing cracks and protecting the fibers even at stresses as high as 172 MPa. It should be noted that the DLC enhanced C/SiC and the DLC C/SiC w/cbs materials had failures in a thermal gradient region located in between the heated gage section and the water-cooled grips. This suggests that the enhancements in these materials are effective at our specific temperature of 1454°C, however the materials may be susceptible to degradation at intermediate temperatures.

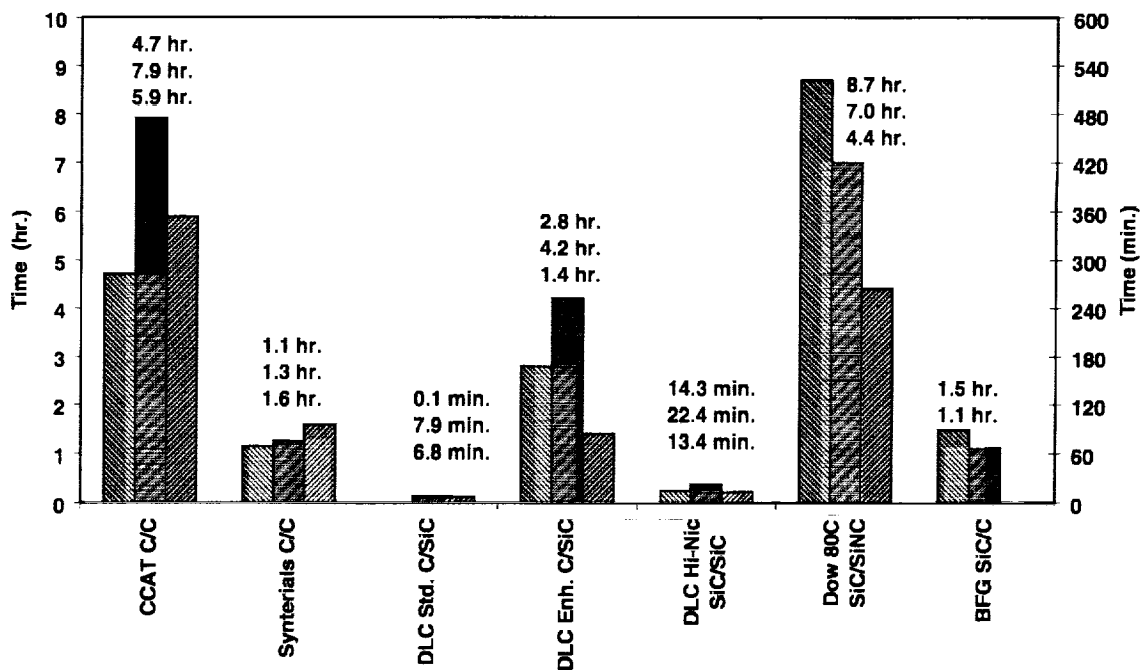
Figure 4—Times to failure for stressed oxidation tests at 1454°C/50% UTS.

Stressed oxidation was also conducted at stresses of 50% of the ultimate tensile strength of each material. The times to failure are shown in Figure 4. Testing at this stress was conducted so that all materials could be evaluated at a stress that seemed to be fairer for all materials regardless of the maturity of the material or the material type. However 50% of the UTS is likely above the first matrix cracking stress for the SiC/SiC and SiC/SiNC materials. Of the seven materials tested at this stress, two materials did better than the rest (CCAT C/C and Dow SiC/SiNC).

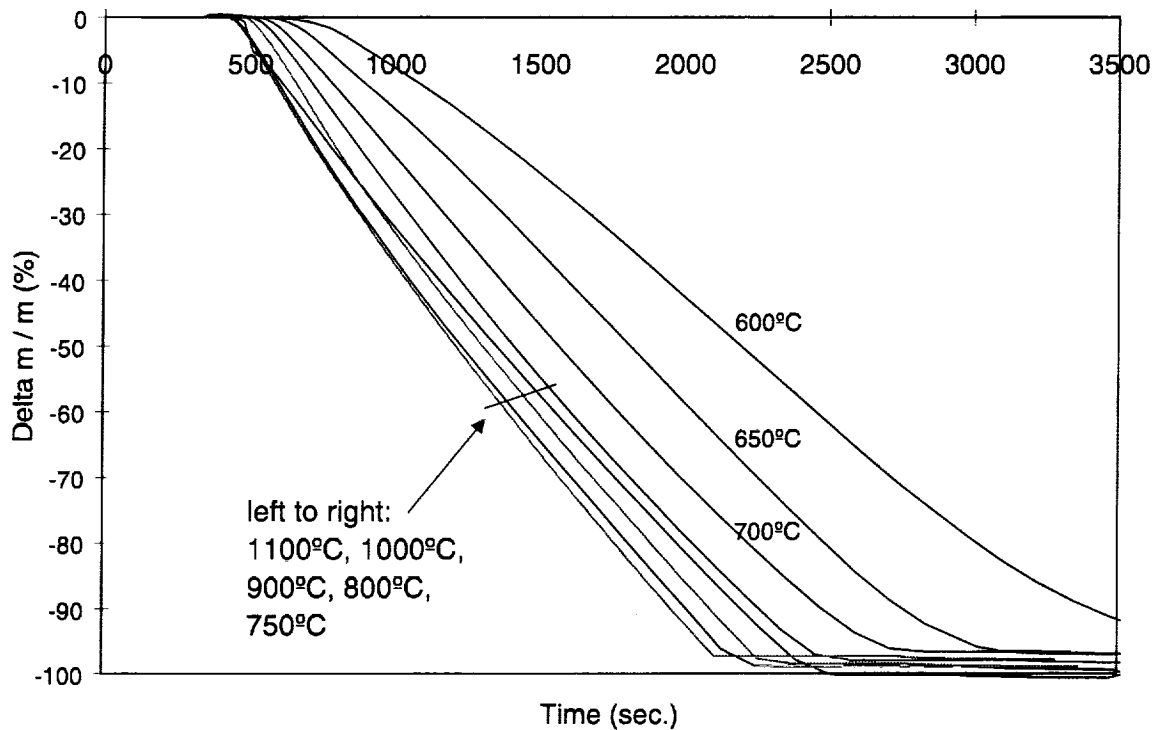
Figure 5—Weight loss versus time of T300 carbon fiber in flowing oxygen at temperatures ranging from 600–1100°C.

Before the effect of a constant load on C/SiC composites is evaluated, it is beneficial to have an understanding of how the material and its fiber constituent behave in unstressed, high temperature, oxidizing conditions. The percent weight loss of T300 carbon fiber versus time at temperatures ranging from 600-1100°C is shown in Figure 5. Slower reaction rates are seen for temperatures ranging from 600-750°C. Faster reaction rates and less of a temperature dependence are observed at temperatures above 800°C. At all temperatures, the approximately 0.4 grams of carbon fiber had completely oxidized away within an hour. These same trends were observed in thermogravimetric analysis (TGA) experiments on T300 fiber conducted by Lamouroux et al [6].

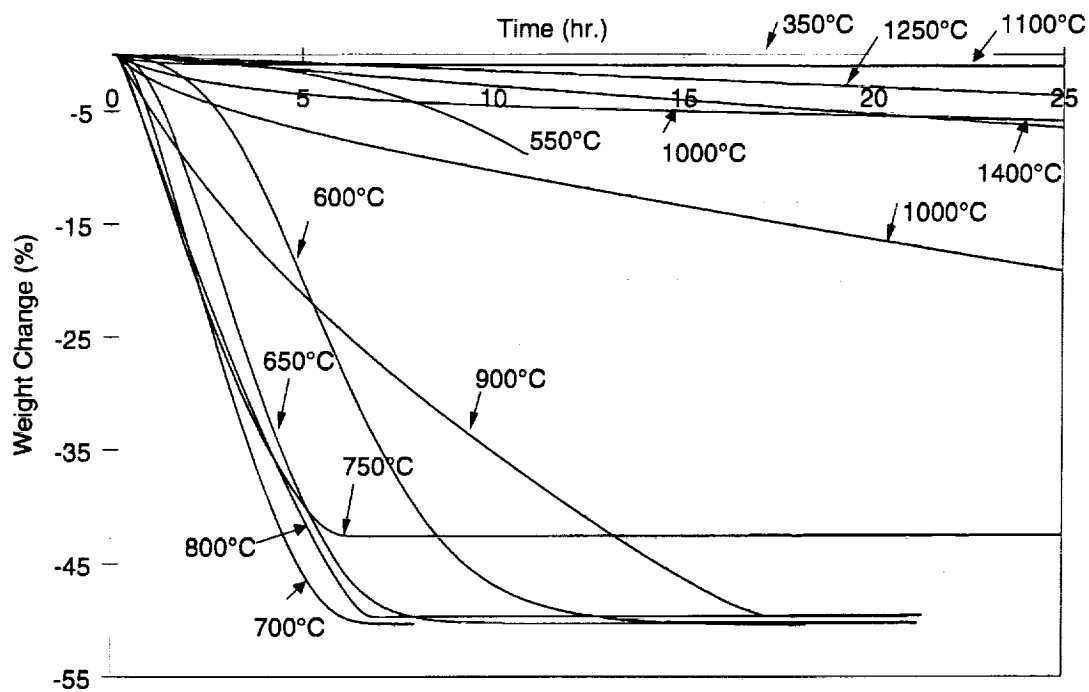
Figure 6—Weight loss versus time of standard C/SiC in flowing oxygen at temperatures ranging from 550–1400°C.

The oxidation of the fully exposed T300 fiber is contrasted by the TGA results of externally-seal coated C/SiC test coupons as shown in Figure 6. At low temperatures, oxygen is able to diffuse into the pre-existing cracks within the composite and react with the carbon fibers. At 550°C, the start of a downward trend in weight loss is observed however the test had to be stopped early. At 750°C, oxidation occurs sooner and at a faster rate. Complete fiber burnout was observed to occur within 5 hours. However, at the higher temperatures, the trends in weight loss and complete fiber burnout did not continue as observed in the TGA tests conducted on the bare T300 fiber. As test temperatures were increased, weight loss rates greatly decreased so that low weight losses were observed even after 25 hours. It should be noted that two tests were conducted at 1000°C and both had different oxidation rates, which are believed to be due to the difference in pre-existing cracks in the external seal coating. Microstructural analysis of polished cross-sections revealed that one sample oxidized uniformly from the outer edges toward the interior while in the other sample significant oxidation occurred from one edge toward the interior but at the opposite edge little oxidation occurred.

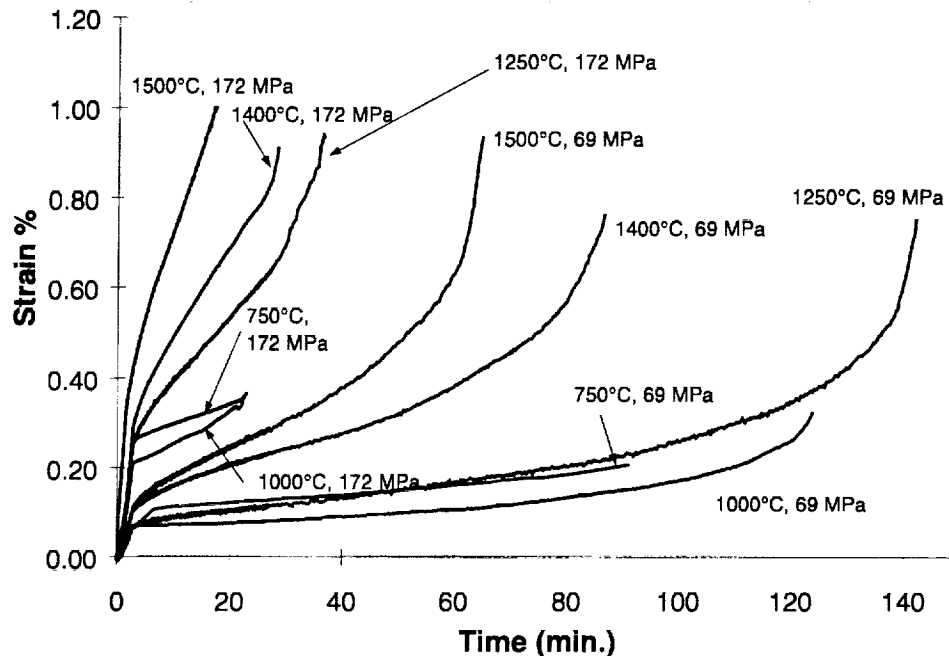
Figure 7—Strain versus time curves from stressed oxidation testing of C/SiC at stresses of 69 MPa (10 ksi) and 172 MPa (25 ksi) and temperatures from 750–1500°C.

When a constant load is applied to C/SiC at elevated oxidizing temperatures, the applied stress opens existing cracks and allows for easier ingress of oxygen to the fibers. At sufficiently high stresses, cracks may be open too wide for crack closure and sealing to occur. The results of stressed oxidation of DLC's standard C/SiC material at stresses of 69 MPa and 172 MPa and at temperatures ranging from 750°C-1500°C are shown in Figure 7 [11]. This batch of material is two years older than the DLC standard C/SiC material tested under the NASA MSFC CMC Material Robustness Program.

In the strain versus time curves, the effect of stress can be seen. As expected, the samples tested at the higher stress had shorter lives. The samples tested at 172 MPa had curves that fall to the left side of the plot while the samples tested at 69 MPa had longer lives and were concentrated to the right side of the plot. Although the times to failure across the temperature range occurred within a fairly narrow range, times to failure increased from 750°C to 1250°C and then decreased at temperatures higher than 1250°C for both stresses. Another effect from temperature is the strain to failure. Samples tested in the higher temperature range showed a much more pronounced tertiary regime and higher strains to failure.

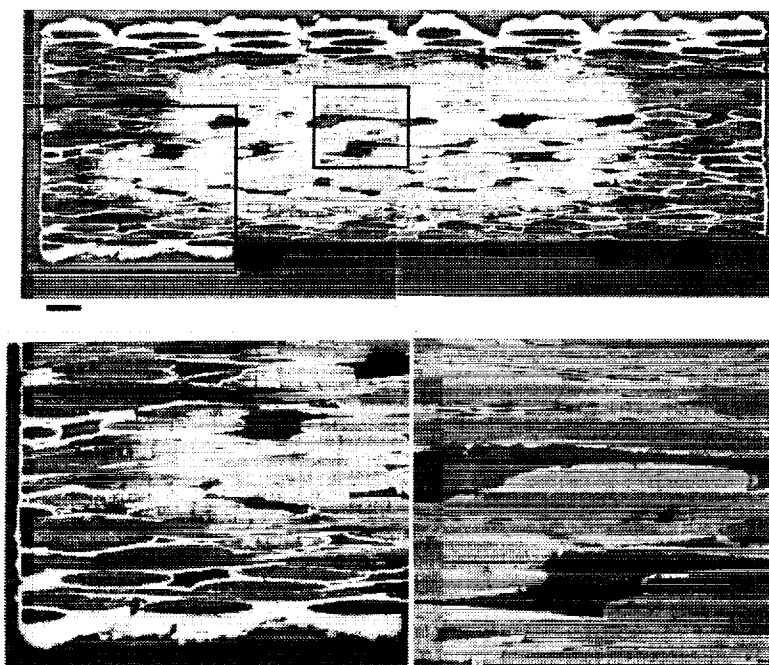
Figure 8—Diffusion controlled kinetics. Optical micrograph of a polished cross-section of a C/SiC sample stressed oxidation tested at 1400°C/69 MPa. Time to failure was 86 minutes. Scale bar in top micrograph equals 0.5 mm.

The model was run at values (i.e. reaction rate constant, diffusion coefficient, and total oxygen concentration at the edge) correlating to conditions at 1400°C in air, and was compared to the microstructure of a tested coupon. Figure 8 shows the polished cross-section of a sample that had been stressed oxidation tested at 1400°C/69MPa. Severe carbon consumption is seen around the perimeter of the sample (darkened regions in the micrograph). In the close-up views, a reaction front can be seen as carbon is immediately oxidized as soon as oxygen is supplied so that the interior is starved in oxygen and no oxygen is present to react with carbon in the interior of the matrix. In the close-up view of the interior, a large void and cracks in the fiber tows are seen, however, no evidence of oxidation is observed. The oxidation patterns shown in Figure 8 suggest a steep gradient in oxygen concentration at the reaction front toward the interior of the sample. This is an oxidation pattern that would be expected from diffusion controlled kinetics. The results from running the model at conditions for 1400°C are shown in Figure 9. The oxidation pattern on a 2-dimensional surface within the fiber bridged region is shown at various stages in the top row of plots. A shrinking core effect is seen as fibers on the outer perimeter are consumed first and then the reaction front moves inward to the next perimeter of fibers. The interior fiber tows remain unreacted until the oxygen supply reaches them. The correlating oxygen concentration plots for one-quarter of the 2-dimensional section are shown in the bottom row. A steep gradient in oxygen concentration can be seen at the edge of the reaction front

toward the interior of the sample. The interior is shown to be deprived of oxygen. These patterns agree well with experimental observations and suggest diffusion controlled kinetics at this relatively high temperature.

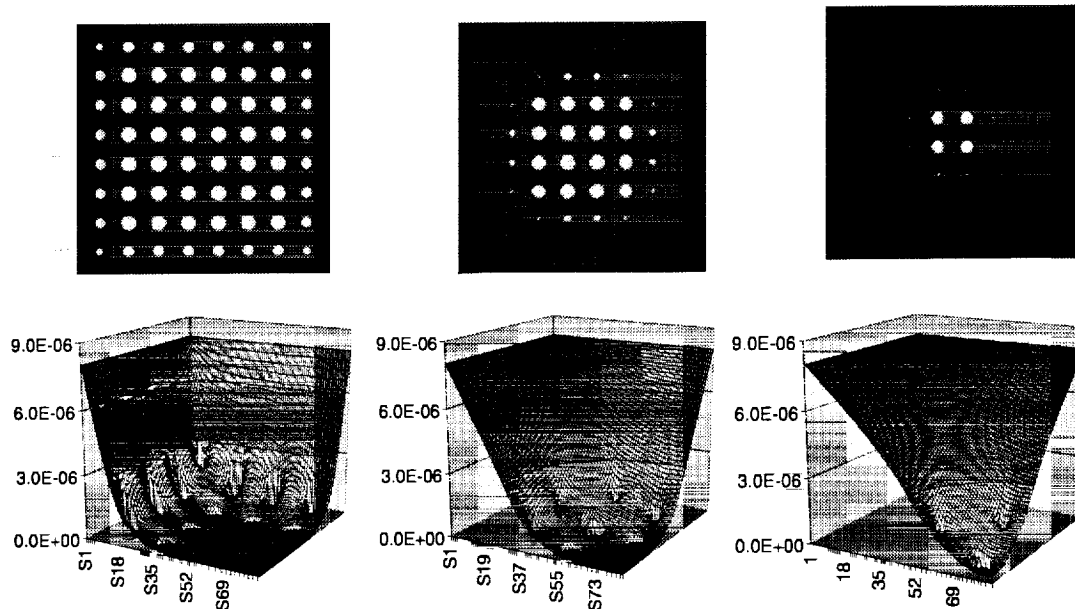
Figure 9—Diffusion controlled kinetics for $Sh = 1.07$ (relating to 1400°C) at 25%, 75%, and 95% carbon consumption of the 8×8 fiber array. The top illustrations are of the remaining area of carbon on the 2-dimensional surface. The bottom plots are of the related oxygen concentrations (mol/cm^3) for one quarter of the surface.

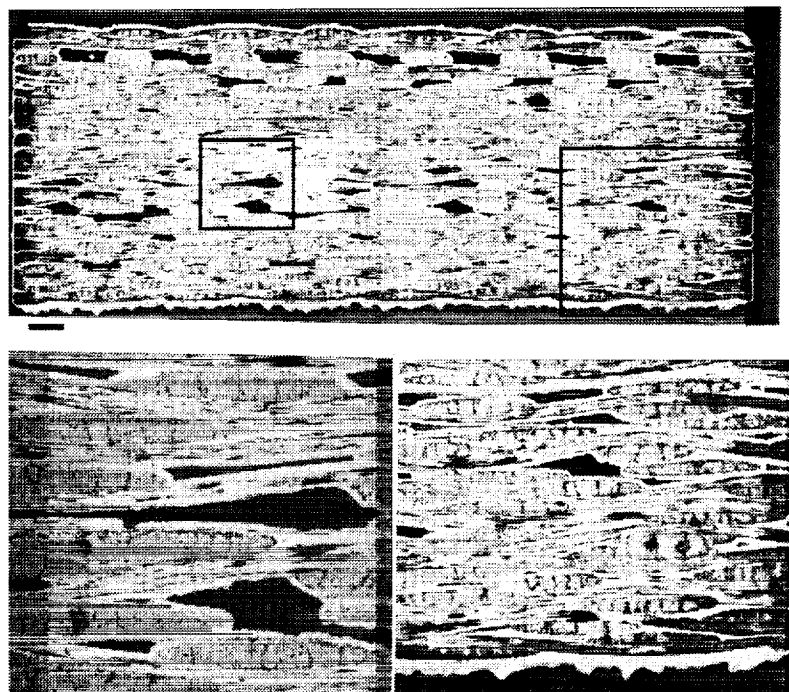
Figure 10—Reaction controlled kinetics. Optical micrograph of a polished cross-section of a C/SiC sample stressed oxidation tested at $700^{\circ}\text{C}/69 \text{ MPa}$. Time to failure was 91 minutes. Scale bar in top micrograph equals 0.5 mm.

The model was also run at values correlating to conditions at 700°C, and were compared to the polished cross-section of a test coupon that had been stressed oxidation tested at 750°C. Figure 10 shows the polished cross-section of a sample stressed oxidation tested at 750°C/69 MPa. Minimal and uniform oxidation is seen along the edge of the sample as well as deep in the interior of the sample along the edges of fiber tows (bundles) and along the matrix cracks within the tows. This pattern suggests that the carbon/oxygen reactions are so slow that oxygen is able to bypass the carbon at the outer edge and saturate the interior at high concentrations so that oxygen is available throughout the matrix to supply the slow reaction process. This is the oxidation pattern that would be expected for reaction controlled kinetics. The results from running the model at conditions for 700°C are shown in Figure 11. The oxidation pattern of the bridging fiber tow array on the 2-dimensional surface is shown in various stages in the top row of plots. The correlating oxygen concentration plots for one-quarter of the section are shown in the bottom row. Uniform carbon reactions and high oxygen concentration are seen throughout the 2-dimensional surface of the matrix. These patterns agree well with experimental observations and suggest reaction controlled kinetics at this relatively low temperature.

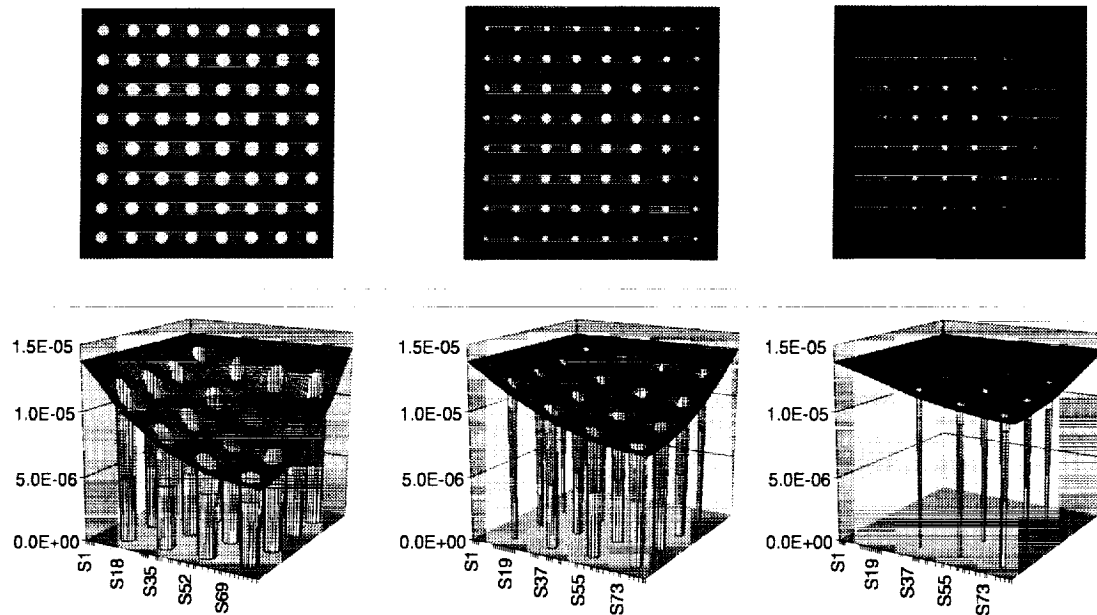
Figure 11—Reaction controlled kinetics for $Sh=1.57E-2$ (relating to $700^{\circ}C$) at 25%, 75%, and 95% carbon consumption of the 6 x 6 fiber array. The top illustrations are of the remaining area of carbon on the 2-dimensional surface. The bottom plots are of the related oxygen concentrations (mol/cm^3) for one quarter of the surface.
